Subj: **East Cazenovia Creek Debris Assessment**
Date: 2/15/2017 2:18:08 P.M. Eastern Standard Time
From:
To:

East Branch Cazenovia Creek
Debris Jams

Location: Town of Aurora

**Debris Assessment
East Branch Cazenovia Creek
Town of Aurora
January 2017**

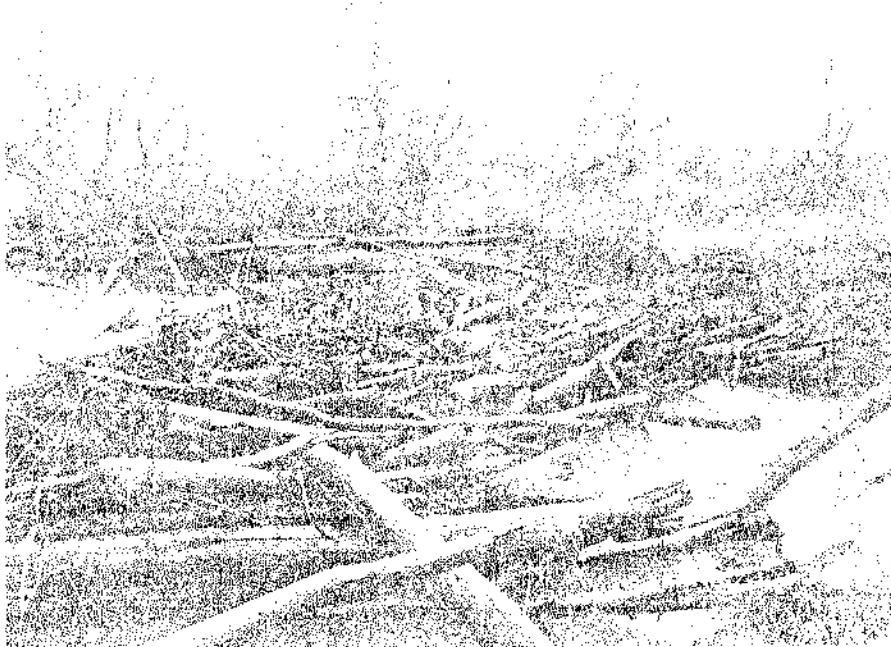
- Major Debris Jam located within Majors Park
- Very large debris snag with multiple limbs
- Entire channel is blocked

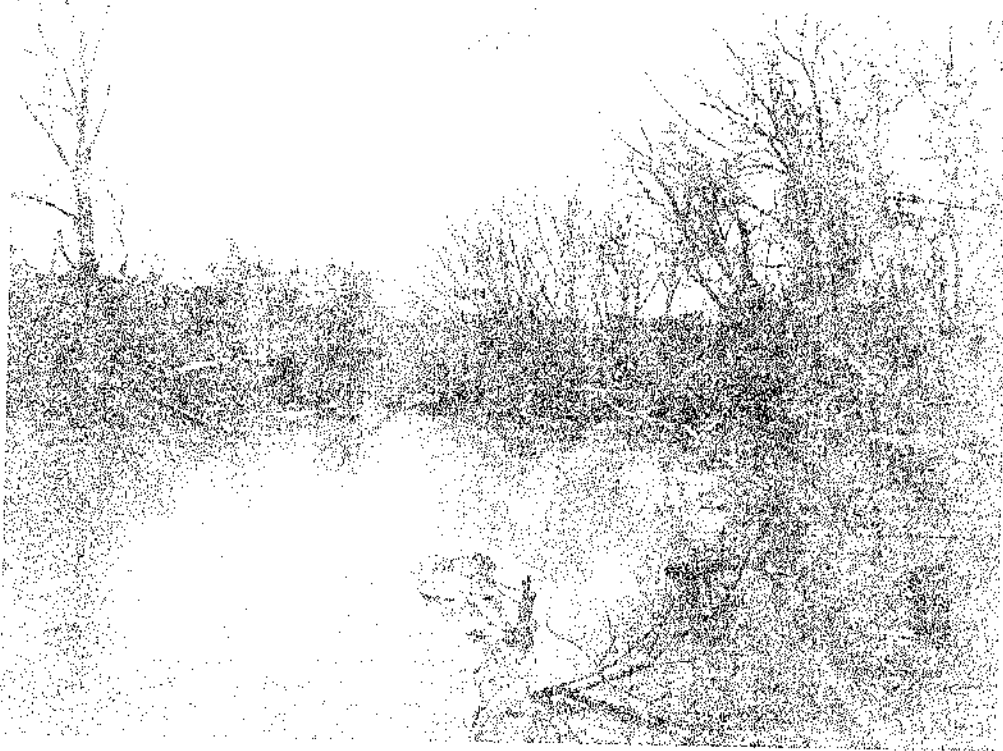
- Debris snag backing up ~2-3' of water
- Old metal bridge frame just downstream
- Diverted flow actively eroding streambanks
